Field Directors' Report: Excavations on Monte Pallano, 2002-2004

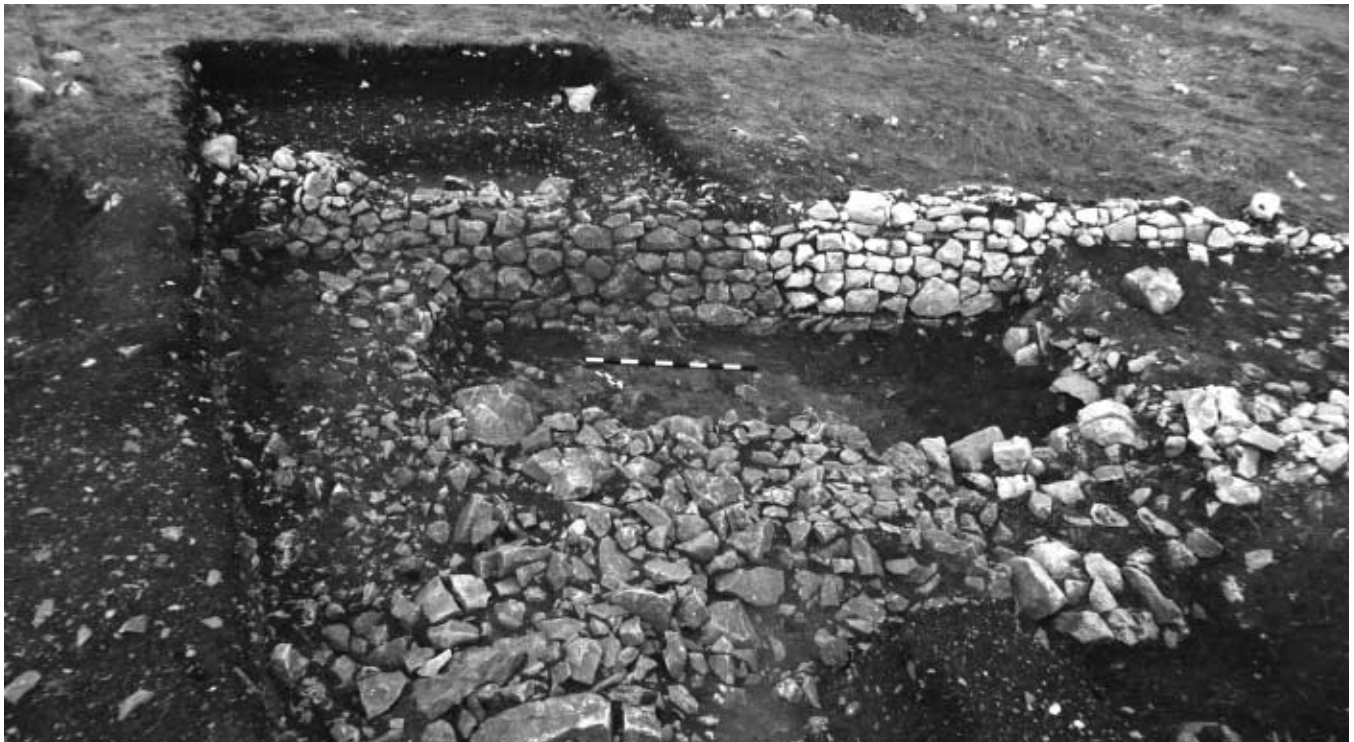
Phase 4 Wall from North

The precise nature of this structure is difficult to determine. The facing indicates that the structure was intended to be viewed from the south-west. The lack of facing on the opposite side and the nature of the fills indicates that at least the lower courses formed a retaining wall, although the original height of the wall and the nature of the area it supported and/or enclosed cannot be determined. However, what is clear is that the fills are made up of rubble derived from a demolished building, and one of considerable status given the exceptional quality of the terracotta tiles.

This phase sees the construction of a new wall and represents a significant change in the nature of land use. The wall is again aligned north-west to south-east, parallel to the Phase 3 terrace wall, and indicates continuity across these phases. The wall runs beyond the western limit of excavation. Attempts to define the eastern end of the wall in the 2004 season identified that it appears to continue towards the car park at the natural entrance to the area from the east. The construction of the wall is different to earlier structures. It is built of relatively small rough limestone blocks, and there is also evidence of mortar bonding. Where excavated to the base to date, the wall is founded on natural clay, although the remnant topsoil was also identified (see phase 1). What is particularly striking about this structure is that it is faced on both sides and therefore has a different function to the previous walls, forming a boundary rather than a terrace or retaining wall. This has left a narrow ‘corridor’ between the Phase 3 and Phase 4 structures.

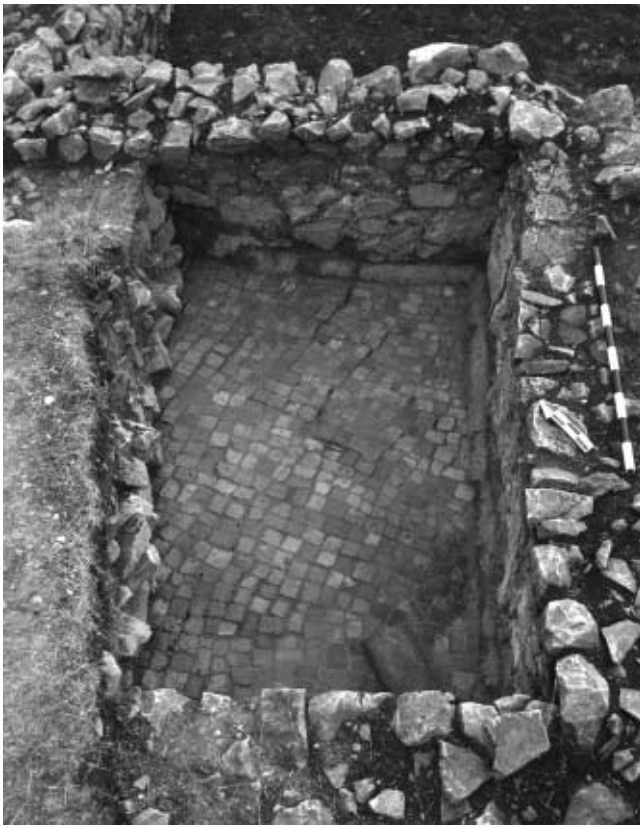
ably still visible on the surface. These structures were reused as a foundation for a new building, with a cut also visible in the rubble fill of the ‘corridor’. The exterior of this small building was poorly constructed of small, rough limestone blocks with low quality facing. However, when the rubble fill was removed the interior proved to be of very high quality, with plastered walls and an intricate tiled floor. The primary use of this building is uncertain, but a curved fragment of Imbrex tile inserted into the corner suggests a secondary use as a cistern.

Phase 6 Tile Floored Structure

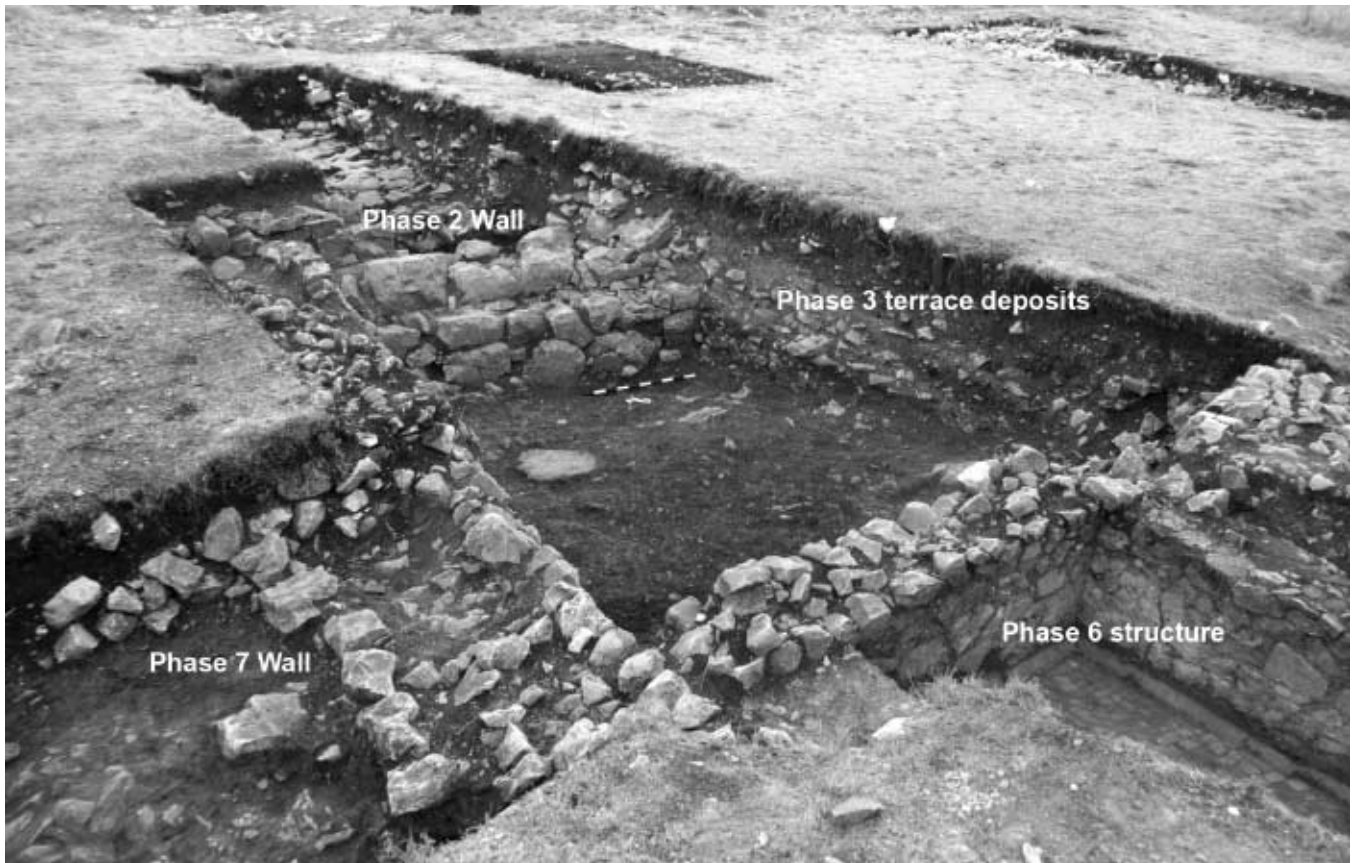
Trench 8700 showing features relating to Phases 2, 3, 6 & 7

Phase 2 represents the earliest phase of activity on the site. It consisted of the base of a wall in trenches 8700 and 8800. In trench 8700 the wall was founded on the natural clay and comprised large, polygonal limestone boulders with courses of smaller stones above and behind, to give a stepped appearance. The wall was roughly faced to the south-west, but had no discernable facing on the northern side, indicating this face was not intended to be seen. Traces of a possible bonding material were identified around the smaller stones and roof tiles had been utilised in its construction. The deposits to the north (rear) of the wall were comprised of naturally derived clay and limestone rubble, although these deposits had been badly disturbed by the excavation of a pit. The function of this pit is uncertain but it may have been excavated to aid drainage.

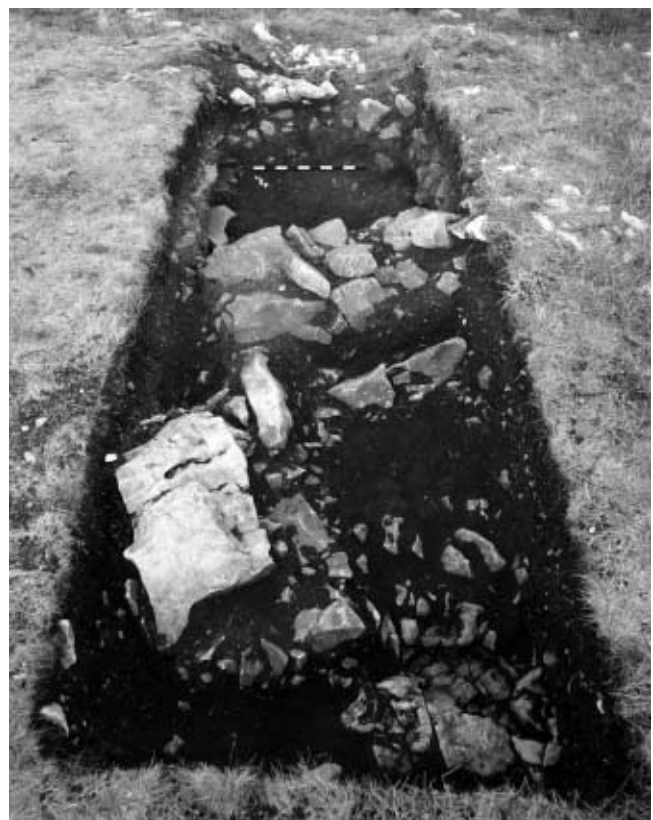
Trench 8900

To date it has not been possible to assign all features and deposits on site to specific phases, although it is hoped that a more complete picture will emerge from the post excavation assessment. Of particular interest here is Trench 8900. This trench contained a stone alignment, interpreted as a contra-terra. Associated with this was a sub-circular pit filled with

broken roof tile, probably as an aid to drainage. At the northern limit of the trench a small pit was identified containing burnt material. The feature was sampled and wet sieving produced evidence of a range of foods, including a quince stone. Quinces are associated with ceremonial feasting in Samnite contexts and consequently this deposit has been interpreted as the remains of such an activity.

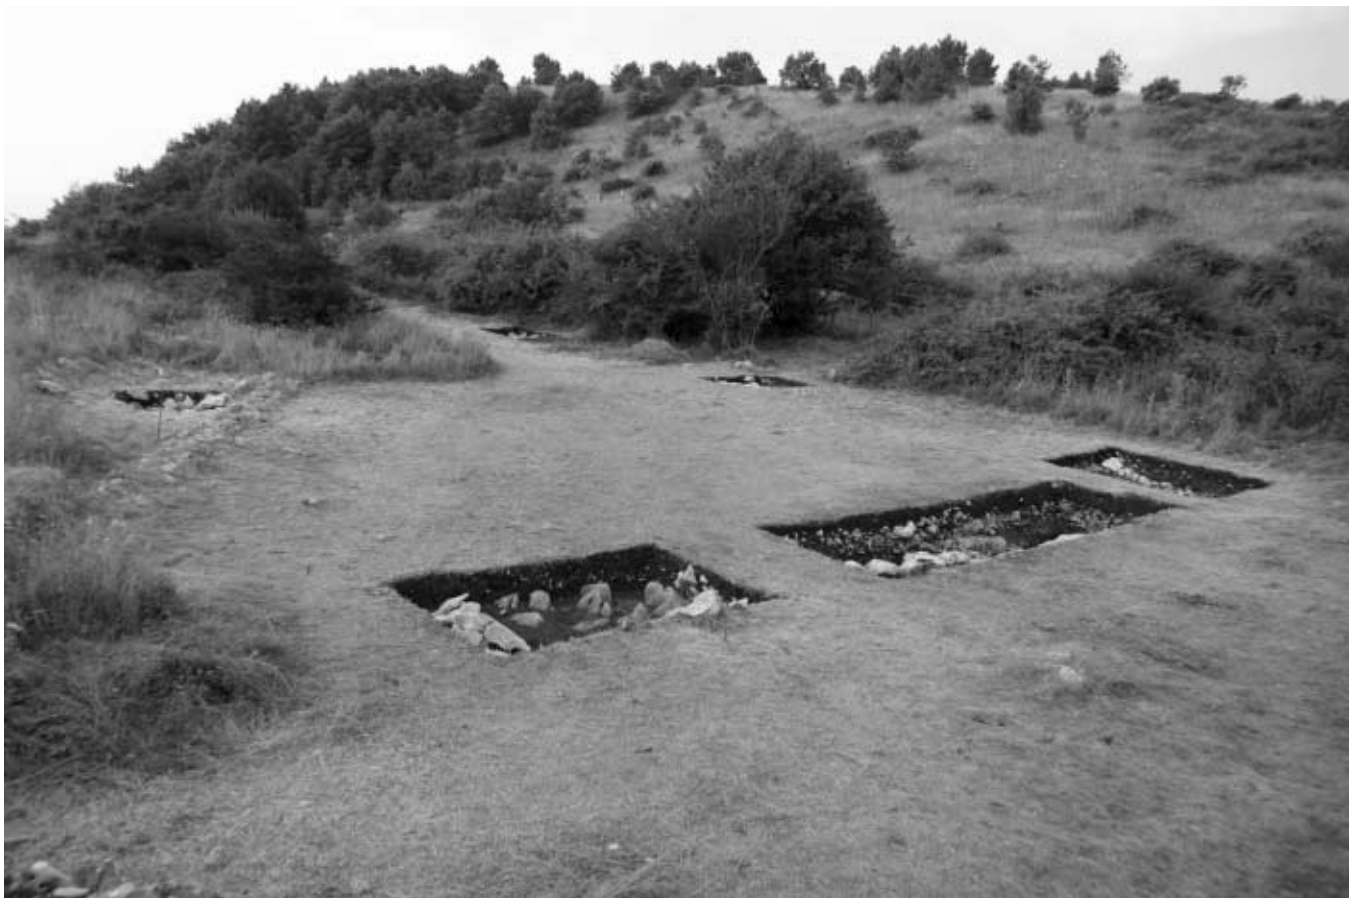
The 2003 season resulted in the full stratigraphic sequence being established across the terrace and this enabled us to move away from area 8000. In 2004 we moved to the east, initially with the intention of tracing the structures of Phases 2, 3 and 4. The Phase 2 structure appears to continue, although an exact match cannot be demonstrated and it is possible that the wall seen in the new area is part of a different structure, and possibly belonging to a different phase of activity. No evidence of the Phase 3 structure was identified,

Overview at the end of the 2004 season

of the structure and its consequent lack of survival. The Phase 4 boundary wall continues in a south-easterly direction towards the car parking area and the gap in slopes of Monte Pallano and La Toretta. The end of this wall has yet to be identified. It now seems likely that it defines the approach to the main area of Roman settlement (the Soprintendenza excavation) from the east. Excavations in 2004 revealed the top courses of this wall. Differences in construction were noted and it is possible that this indicates periods of reconstruction.
